BUREAU OF SHIPS GROUP TECHNICAL INSPECTION REPORT

U.S.S. BUTTE (APA68)

TEST ABLE

OPERATION CROSSROADS

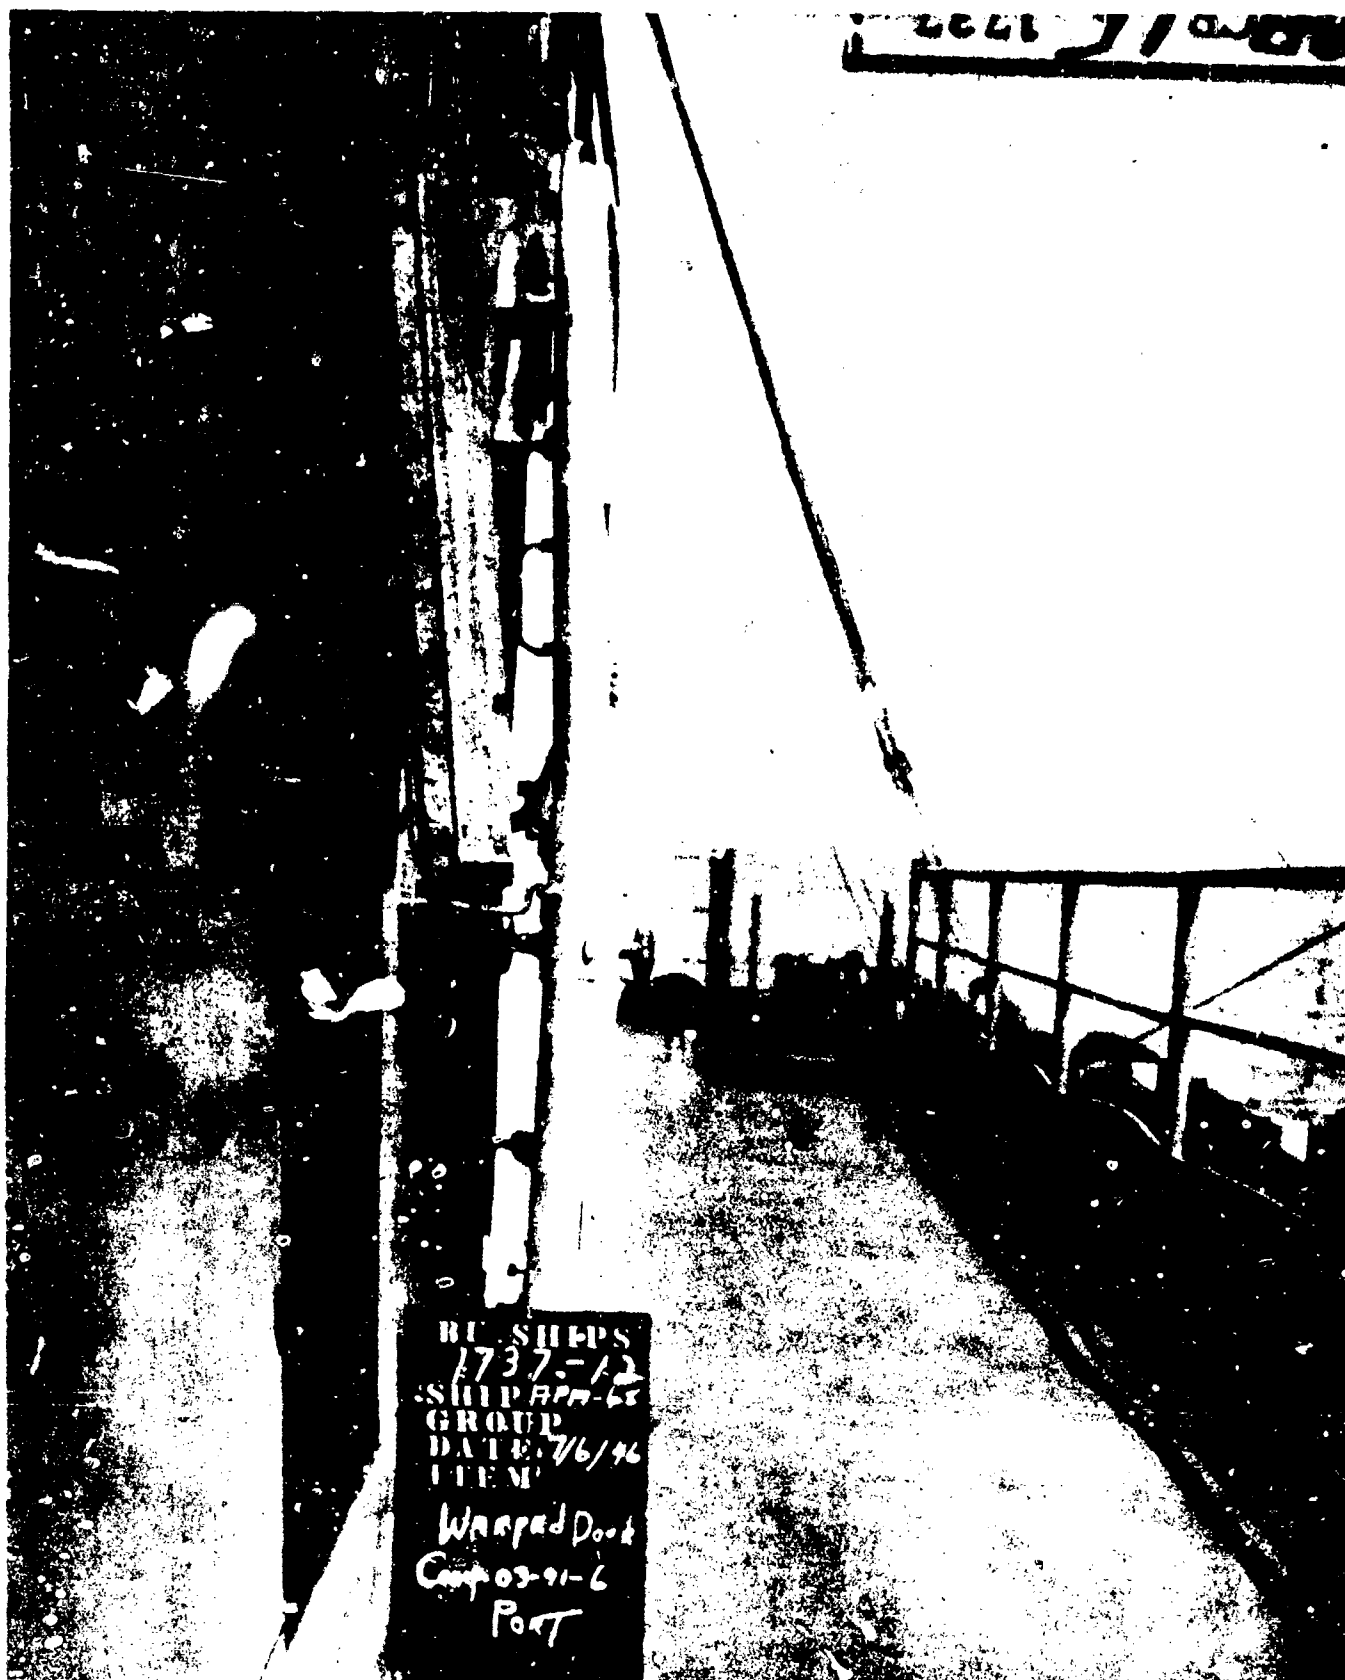
AA-CR-65-1737-12. Dished door 03-41-6.

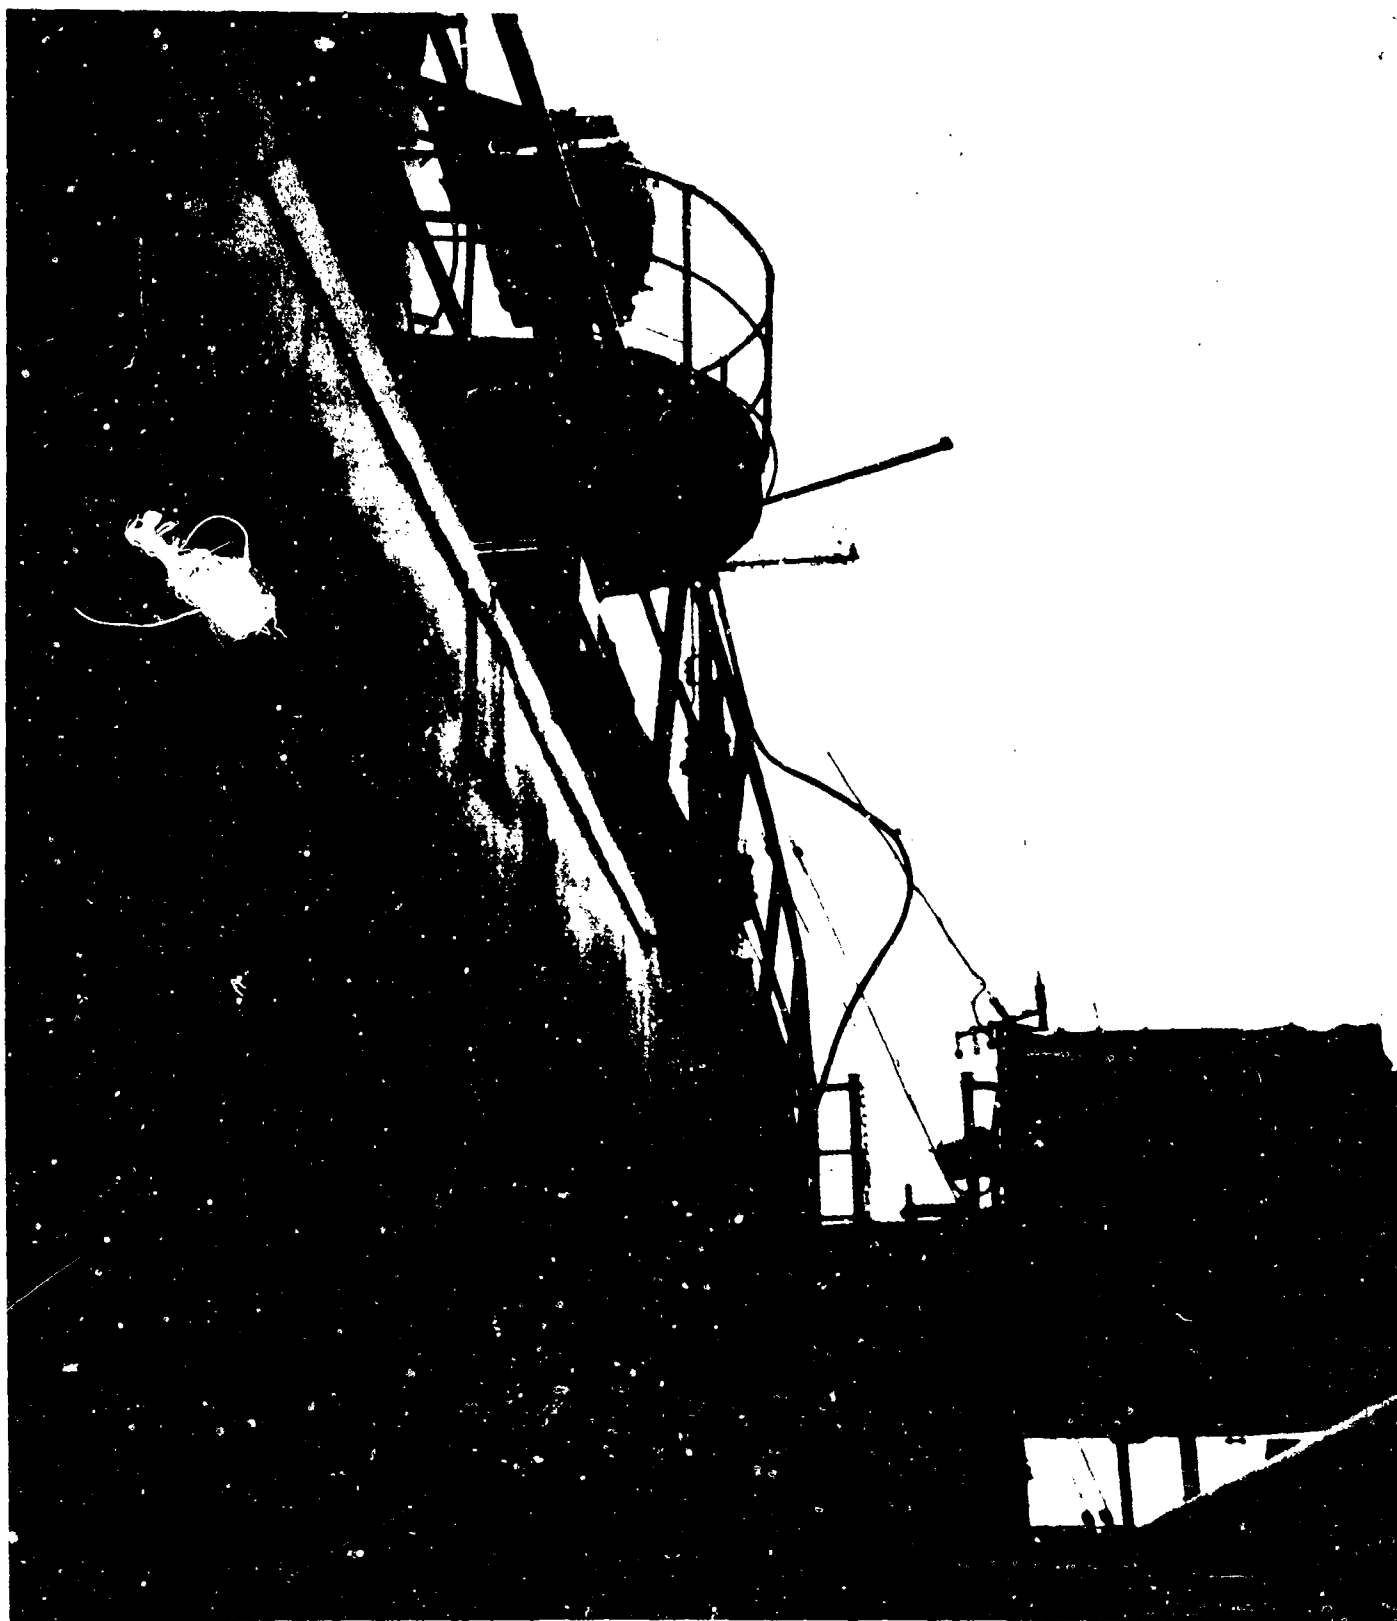
The port flag bag is dished on the outboard and after sides. The starboard flag bag is dished on the inboard side and the welded connection to the signal bridge is cracked. The adjacent railing is bent outboard and the canvas wind screen is torn off. The pipe to which the bottom of the screen was secured was torn loose at the connection to the bulkhead and was bent. (Photographs 1739-9, page 46 and 2103-5, page 47).

AA-CR-88-2103-5. Twisted securing pipe for wind screen. Looking forward on navigating deck.

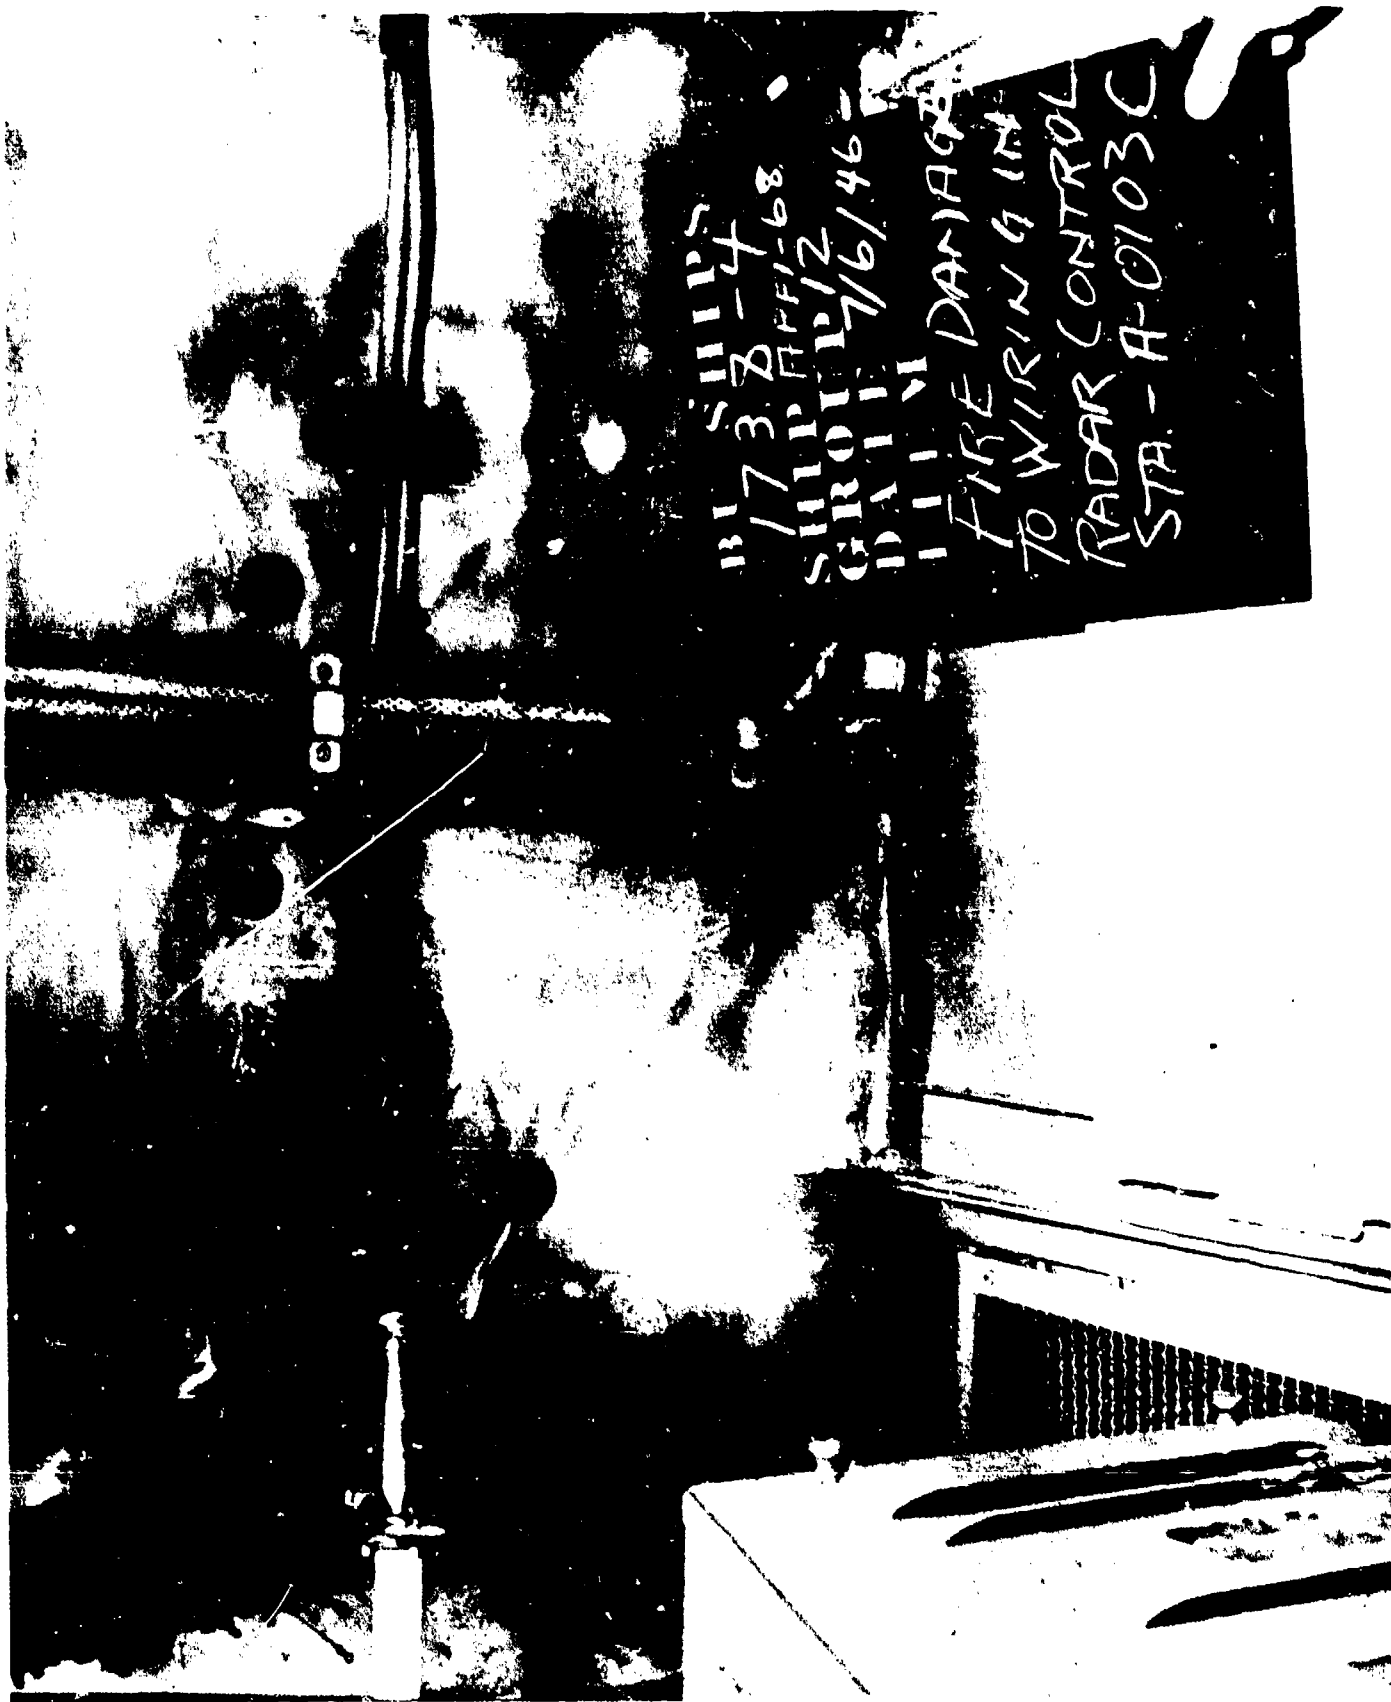
The second fire started in an 8' hawser faked out down on top of the forward deck house, frame 27-36. The fire ignited a cargo net and temperature within the 40MM R.S. Room A-101-M reached a maximum of 130 degrees F. (Photograph 1738-2, page 58). Heat was conducted through the insulation below the 02 deck and damaged the insulation on wiring in the Radar Control Station A-0103-C. (Photograph 1738-4, page 59).

AA-CR-65-1738-4. Fire damage to wiring in Radar Control Station.
A-0103C.

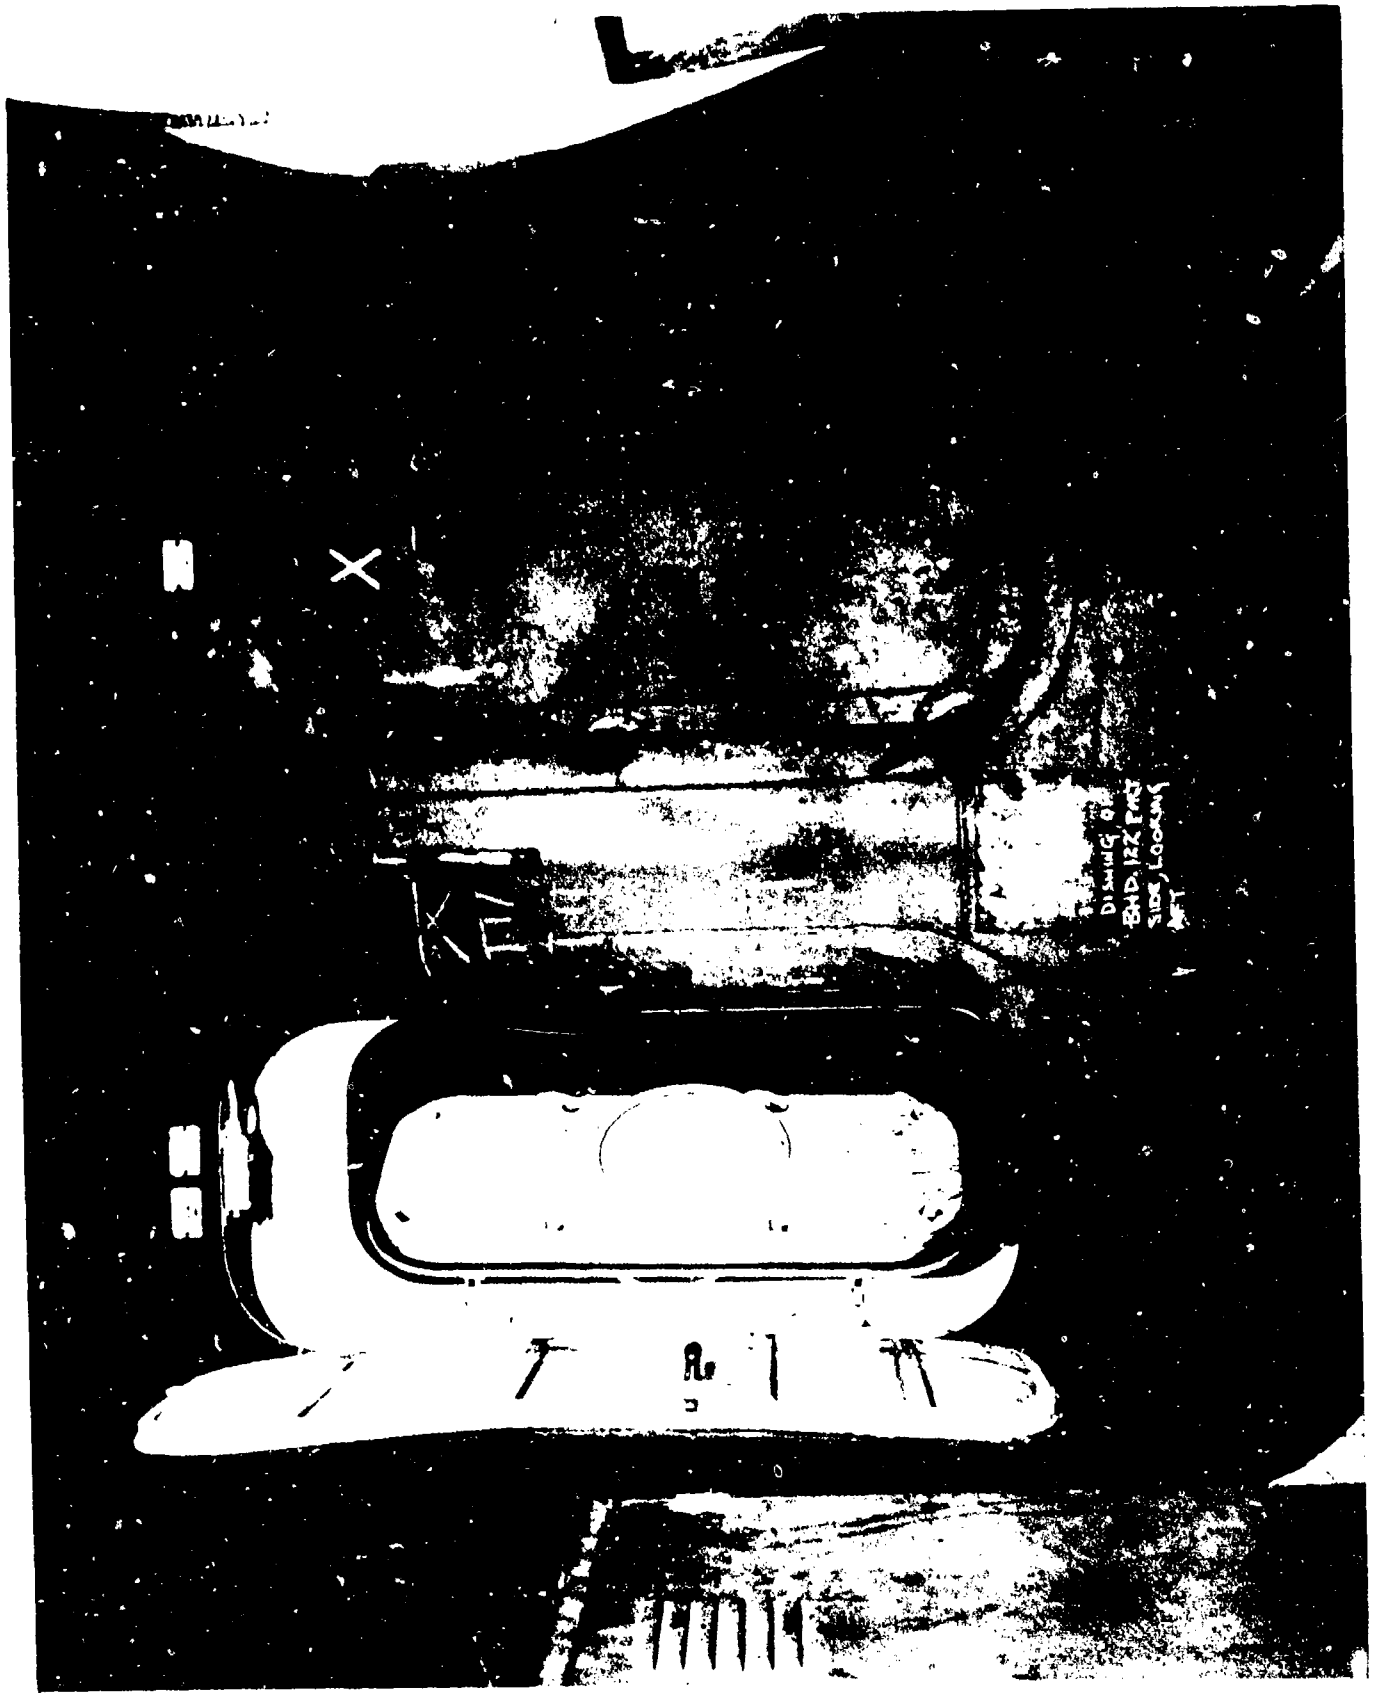
Structural damage is superficial. Both stacks are slightly dished. Bulkhead 122 in the port main deck weather passage-way and two doors in this bulkhead are dished. Exposed super-structure bulkheads having long spans are slightly dished. The flag bags are dished. The weld of one attachment of the starboard bag is cracked. Miscellaneous canvas covers and wind screens on topside are torn and securing pipes are bent. One signal halyard is parted. There is considerable warping of some bulkheads and decks incident to two fires which burned 8 inch hawsers.

AA-CR-65-1738-9. Bulkhead 122, port main deck, looking aft.

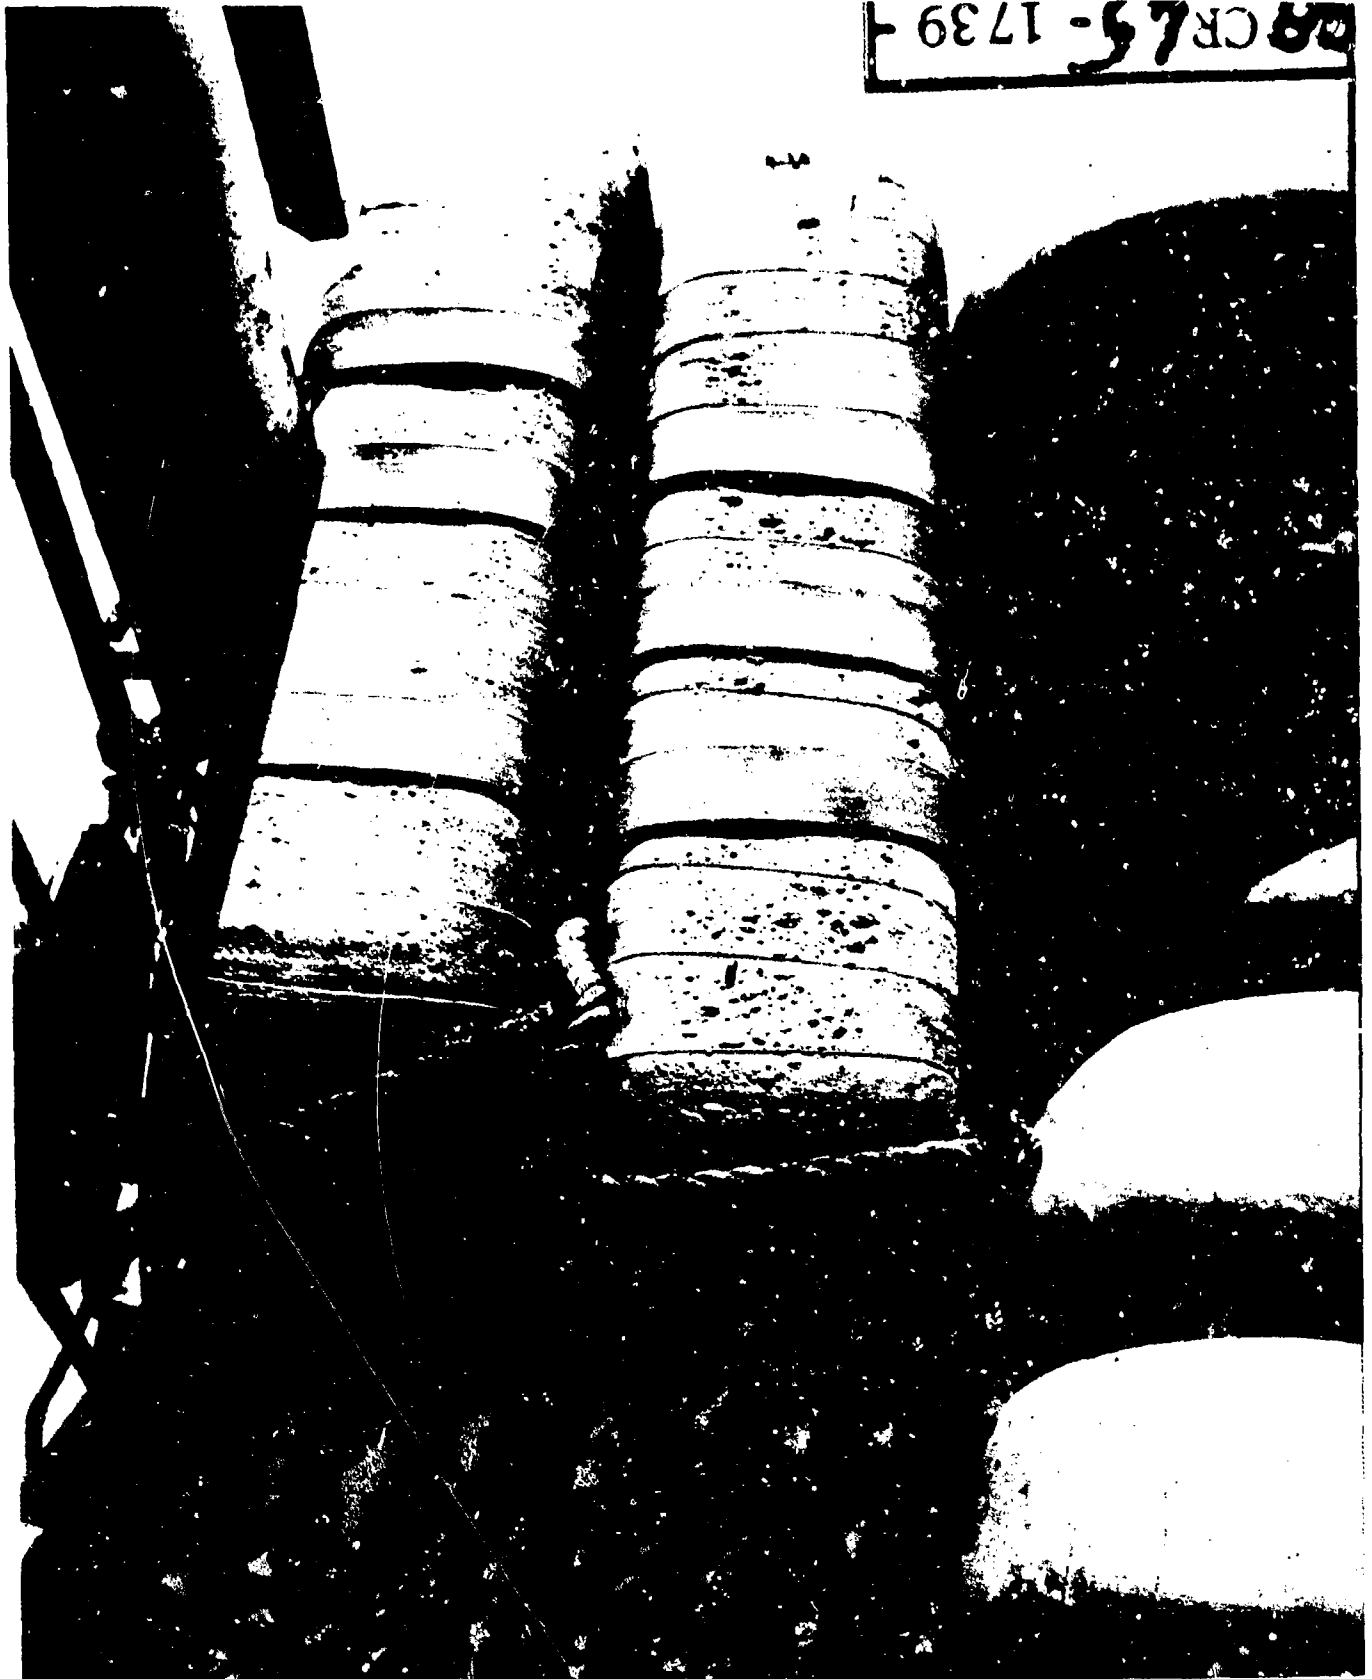
Blistering and scorching of paint is peculiarly localized. A good deal of localization can be attributed to older paint or rust and/or waterstained paint. (Photographs 1739-1, page 67, 1739-2, page 68, and 1739-8, page 69). Relatively fresh paint seems to be fairly resistant to scorching and blistering. Baked alkyd paint as typified by the coating on U.S. Army test equipment has practically no or very slight scorching discernable. Painted wood or canvas showed far more blistering by radiation than did similarly placed steel surfaces. (Photograph 1739-8, page 69). Red striping paint (Toluidine-Toner) ground in Alkyd was practically vulnerable to radiation effect, having entirely burned off in three different places.

AA-CR-65-1739-8. Paint blisters on life raft covering.
